Well Construction Details and Log of Boring RIPZ-16

Final Remedial Investigation Report
Casmalia Resources Superfund Site
Casmalia, California

E9-27

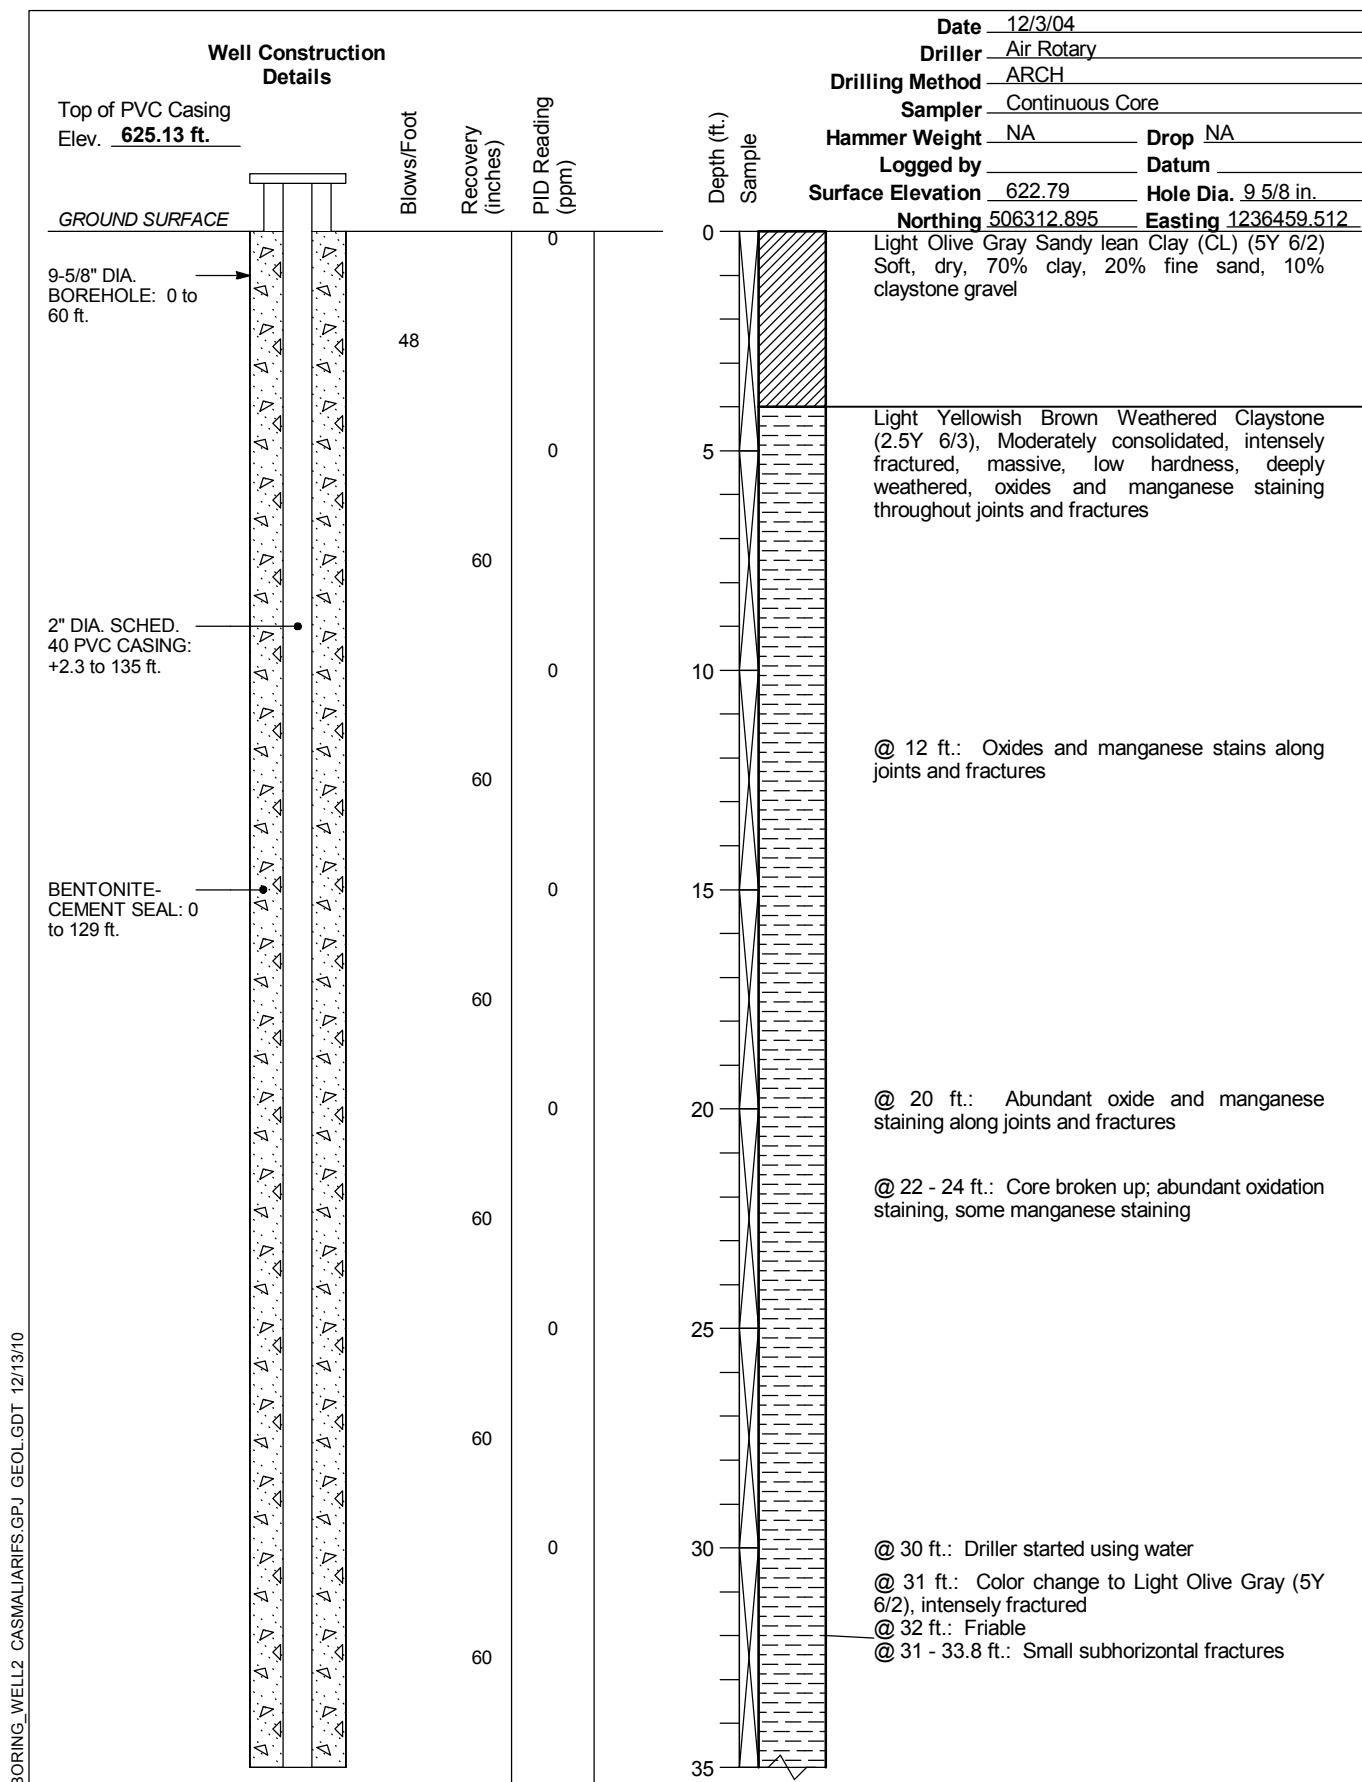
Date 12/3/04
 Driller Air Rotary
 Drilling Method ARCH
 Sampler Continuous Core
 Hammer Weight NA Drop NA
 Logged by Datum
 Surface Elevation 622.79 Hole Dia. 9 5/8 in.
 Northing 506312.895 Easting 1236459.512

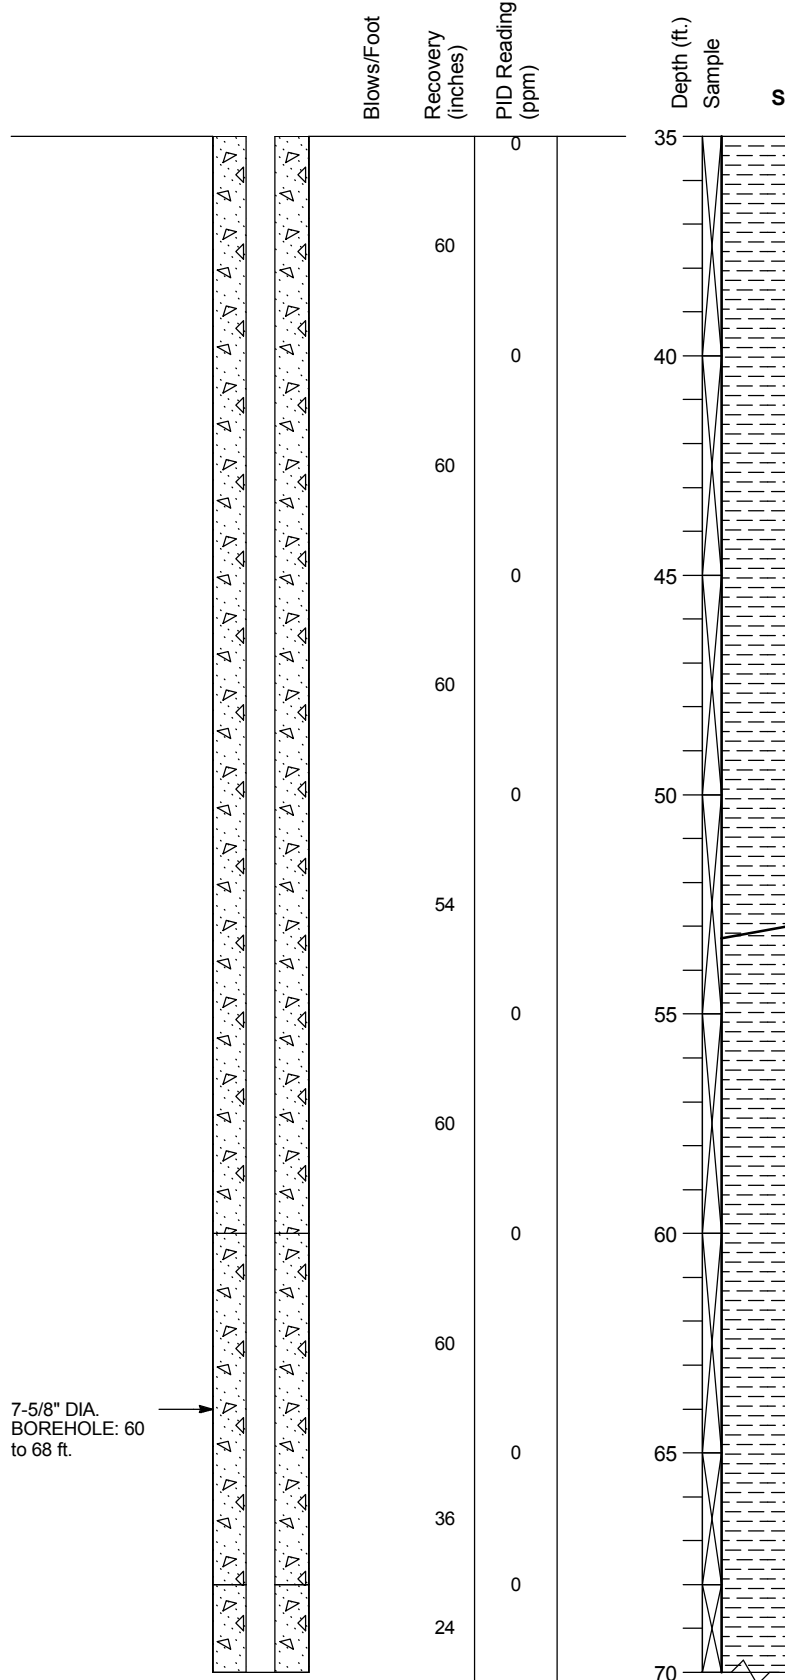
@ 35 ft.: Moderately fractured, moderately weathered, abundant oxide staining along joints and fractures

@ 36.2 ft.: Small subhorizontal fractures
 @ 36.7 - 40.8 ft.: Subangular fractures

@ 40 ft.: Intensely fractured, oxidized; alternates between Light Olive Gray and Olive Gray (5Y 5/2)
 @ 40.1 and 41 ft.: Fractures

@ 42.3 and 42.7 ft.: Subhorizontal fractures
 @ 43 ft.: Gypsum coating subangular fracture

@ 46 ft.: Gypsum, some fractures have no oxidation staining

Dark Gray Unweathered Mudstone (5Y 4/1), Moderately consolidated, massive, very little fracturing, low hardness, weak, little to no weathering

@ 68.1 ft.: Four small subhorizontal fractures, two upper fractures with iron oxide

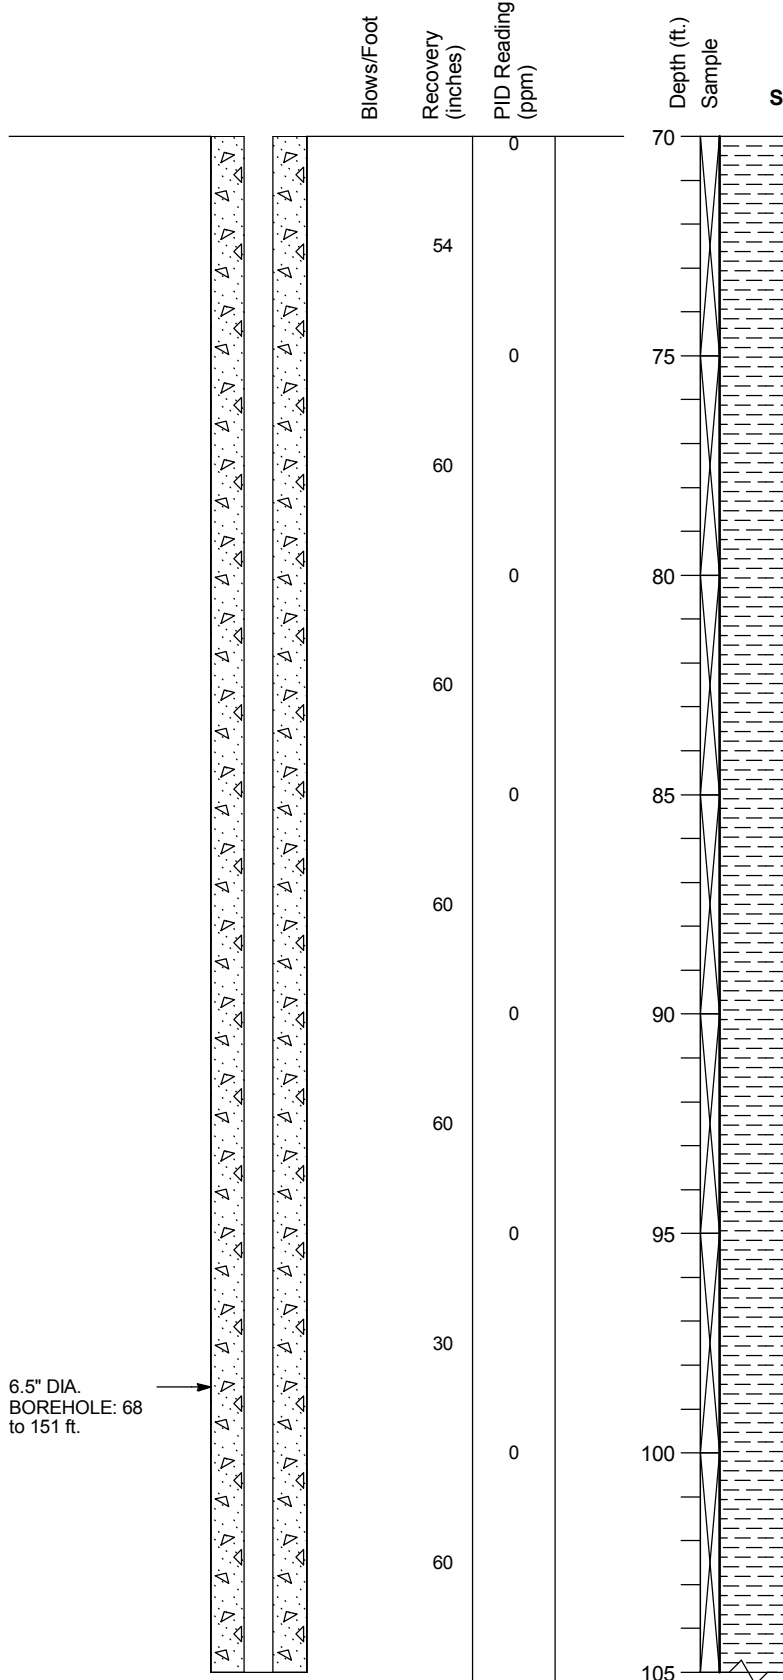
@ 78.2 ft.: One small subhorizontal fracture, no oxides

@ 79.7 and 80.5 ft.: Video survey shows white layers

@ 81 ft.: Massive, unfractured

@ 84.4 ft.: White layer

@ 90, 92, and 93 ft.: White layers

@ 102 ft.: White zone shown in optical televiewer survey, 101 shown in video survey

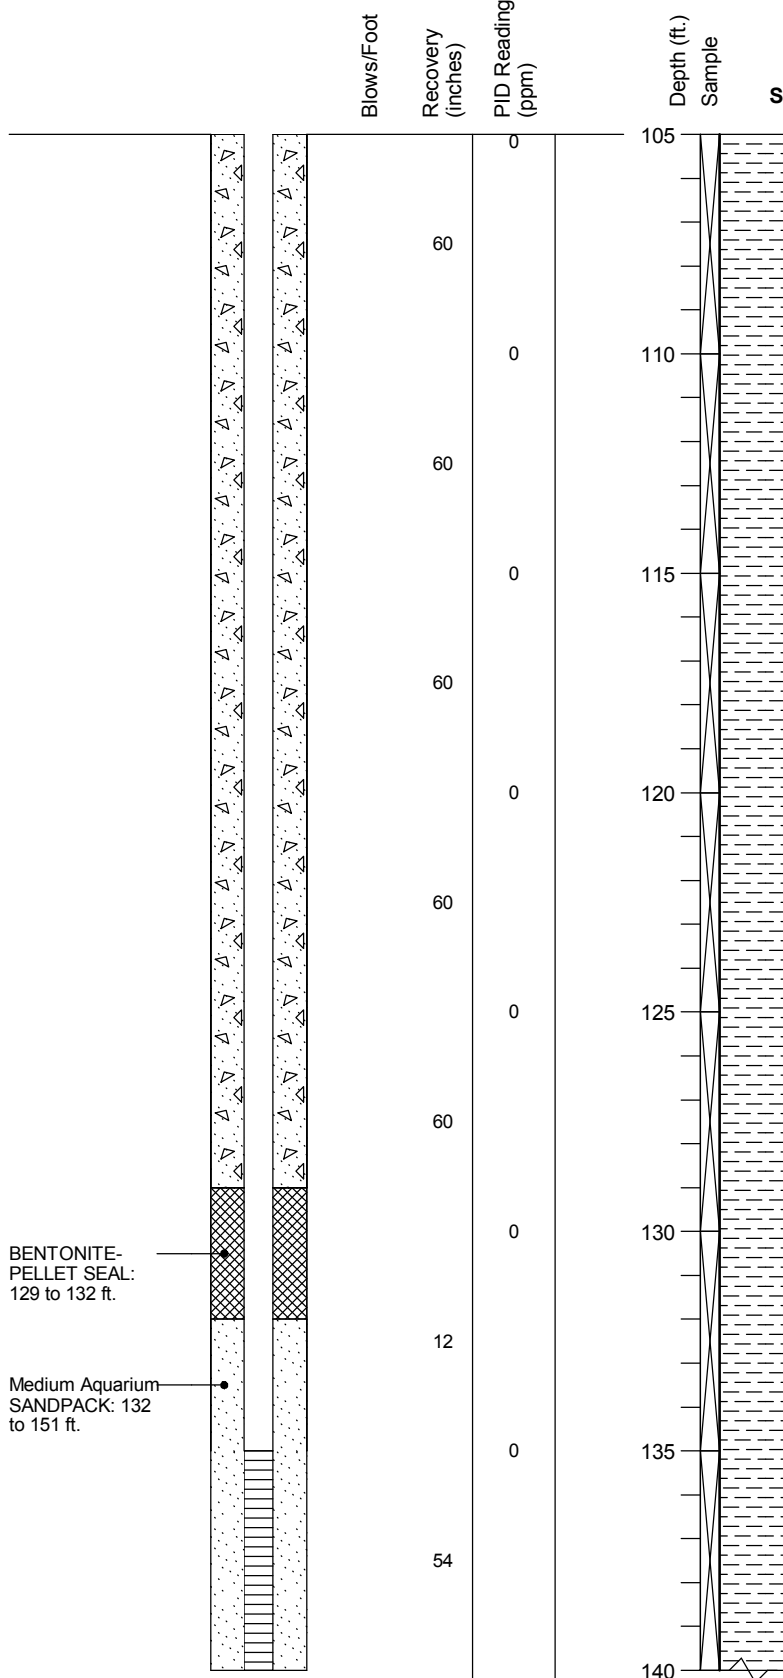
@ 106 ft.: Massive, unfractured

@ 110.8, 111.6, 114.8, 115.8, and 117.8 ft.: Small subhorizontal oxides

@ 114.5 ft.: White zone

@ 118 ft.: Video survey shows white layer; water seen running down borehole sidewall from above

@ 118.8 ft.: Small minor poorly-developed vertical fracture, some white oxide

@ 120.5 ft.: Harder drilling, rock is moderately strong from 120.5 - 124 ft.; small subhorizontal and subangular fractures from 120.9 to 124.2 ft.

@ 128 ft.: Video survey shows vertical fracture

@ 130 ft.: Optical televiewer shows white layer

@ 134 ft.: Video survey shows subhorizontal fracture

@ 137 ft.: Video survey shows high angle fracture with water cascading out

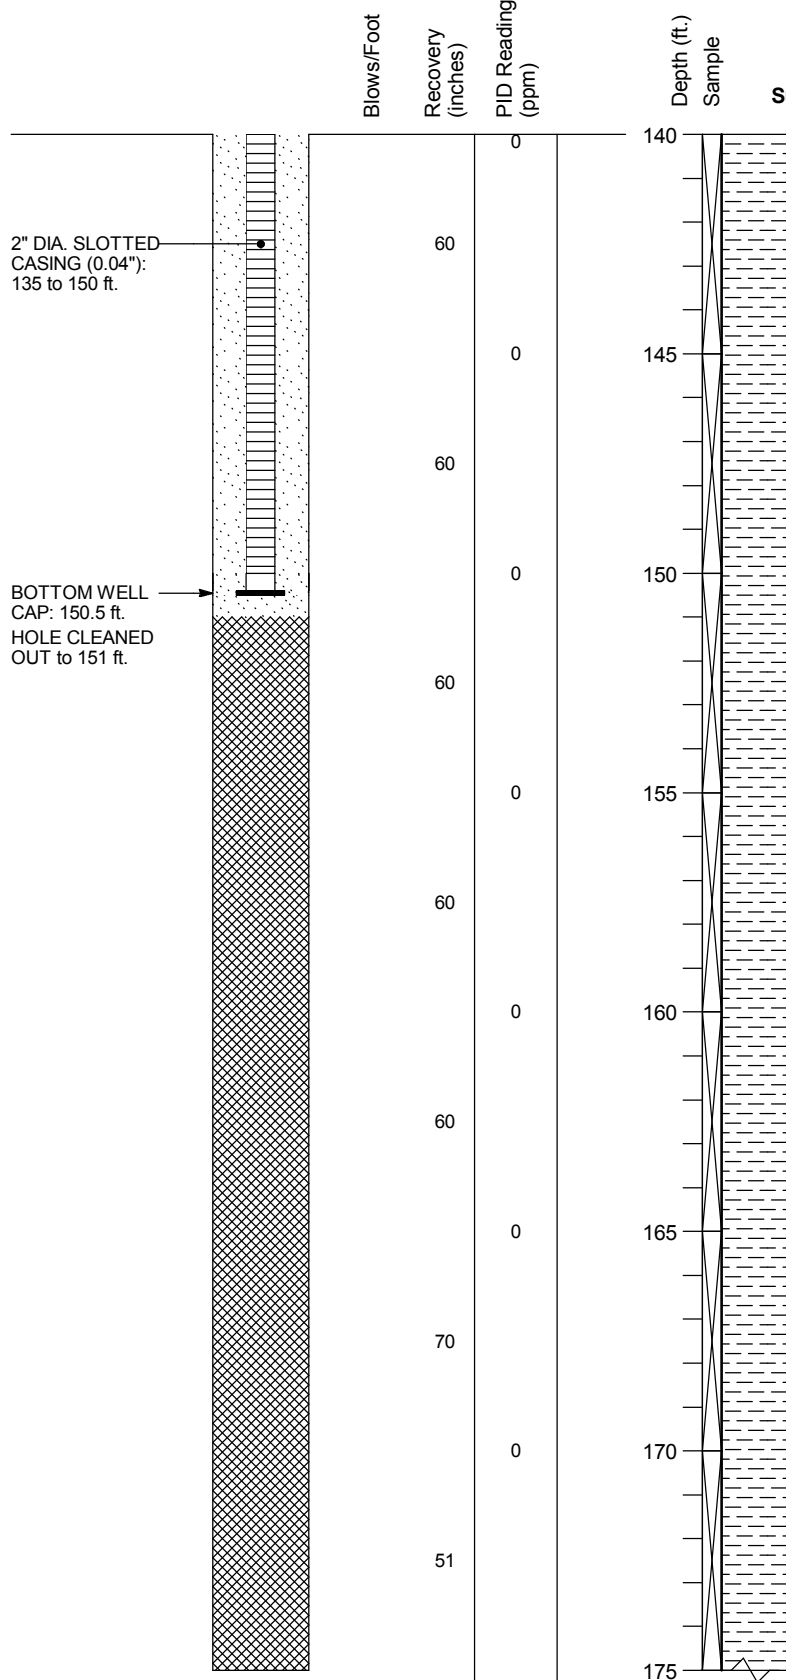
@ 141.4 ft.: Subhorizontal fracture; some slight iron oxide staining from 141.4 - 145.1 ft.

@ 146.6 ft.: Subangular fractures from 146.6 - 151 ft.

From 153.1 - 154.2 ft.: Subhorizontal fractures

@ 154.5 - 155.5 ft.: White zone; subhorizontal fractures at 155.8, 158.2, 158.5, 158.8, 160.2, 161.8, and 162.2 ft.

@ 163.6 ft.: Subhorizontal fractures

@ 165.3 - 172 ft.: Subhorizontal fractures

@ 167 ft.: Video survey shows high angle fracture

@ 171 ft.: Video survey shows 20° off horizontal fracture
 Vertical fractures from 172 - 173 ft., 172 - 172.5 ft., 175 - 176 ft., 174.8 - 175.2, and 175.4 - 176; some white oxides

@ 173 ft.: Video survey shows fracture emitting water with suspended solids

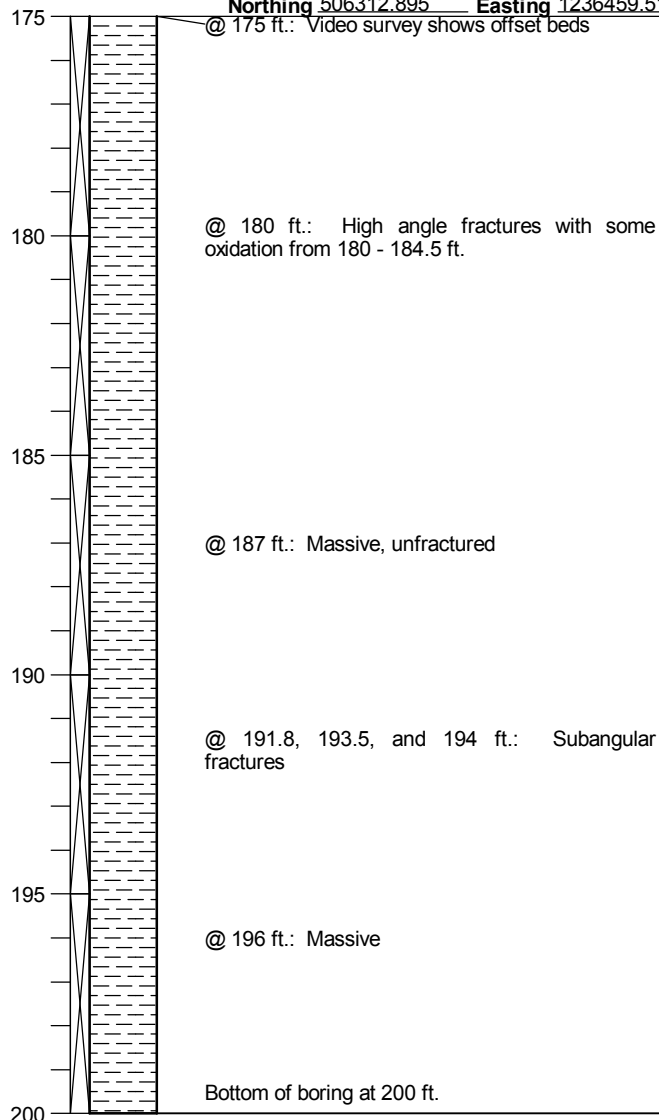
BENTONITE-
PELLET
BACKFILL: 151 to
200 ft.

Date 12/3/04
Driller Air Rotary
Drilling Method ARCH
Sampler Continuous Core
Hammer Weight NA Drop NA
Logged by _____ Datum _____
Surface Elevation 622.79 Hole Dia. 9 5/8 in.
Northing 506312.895 Easting 1236459.512
